Integration and Comparison Methods for Multitemporal Image-Based 2D Annotations in Linked 3D Building Documentation

Jakob Taraben * and Guido Morgenthal

Chair of Modelling and Simulation of Structures, Bauhaus-Universität Weimar, Marienstraße 13a, 99423 Weimar, Germany; guido.morgenthal@uni-weimar.de

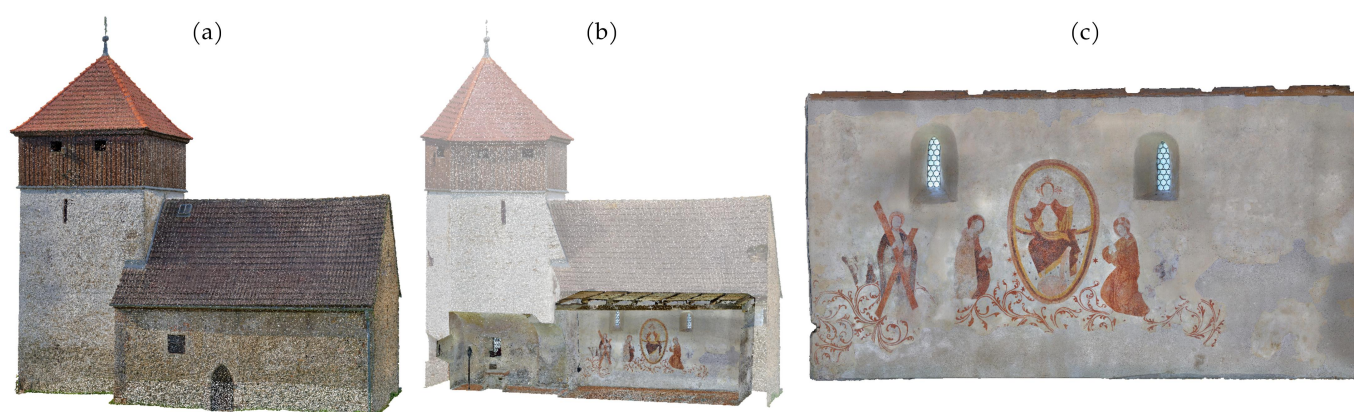
Figure 1. The captured point clouds of the Wehrkirche Döblitz (a) from outside and (b) of the main hall and the sanctuary at the ground level and (c) the reconstructed orthophoto of the wall painting.

- A collection of 1881 images (9504×6336 pixel) captured with a mean distance of 1.5 m (1.0 m for the wall painting);
- A sparse point cloud with 6.3×10^6 points from the photogrammetric reconstruction (approximately 27.4×10^3 points/m²);
- The estimated extrinsic parameters of the camera for each image (see Figure 3);
- A computed orthophoto of the wall painting with a size of approximately 36 m² and a resolution of 117.33 pixel/mm² (see Figure 1).

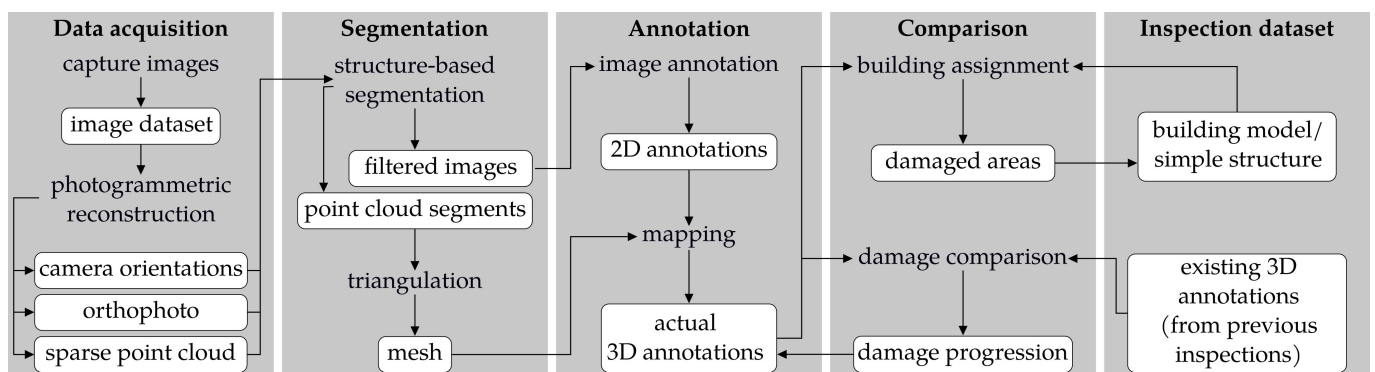
Figure 2. Flowchart of the proposed process pipeline to integrate 2D annotations in 3D models and to perform an automated damage comparison (data entities in the white boxes, processing steps without frame).

The last step of the automated analysis workflow (see Figure 2) is the comparison of the previously assigned damage groups and the identification of local geometrical changes of damages to derive damage progression indicators.

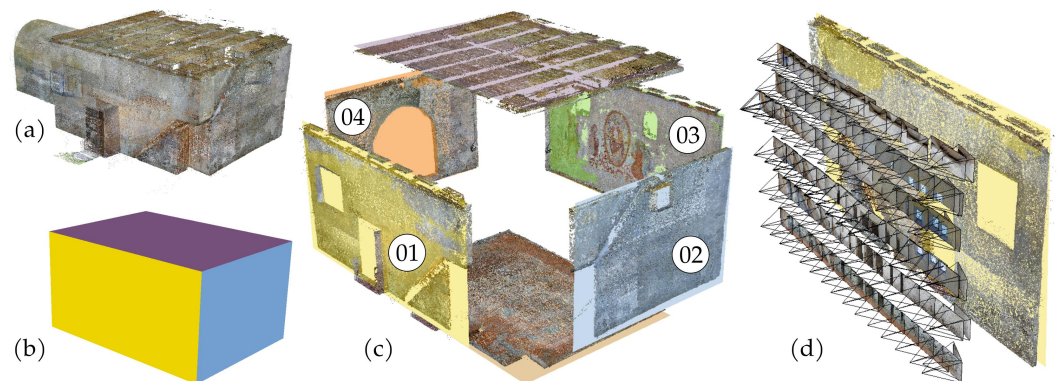
Figure 3. Segmented building parts of the main hall with manually modelled building elements: (a) initial point cloud of the interior, (b) modelled facets for floor, walls, and ceiling, (c) explosion drawing of the point cloud segments including the numbering of the walls, and (d) subset of Wall 01 with the extracted image set as camera orientations from the inside.

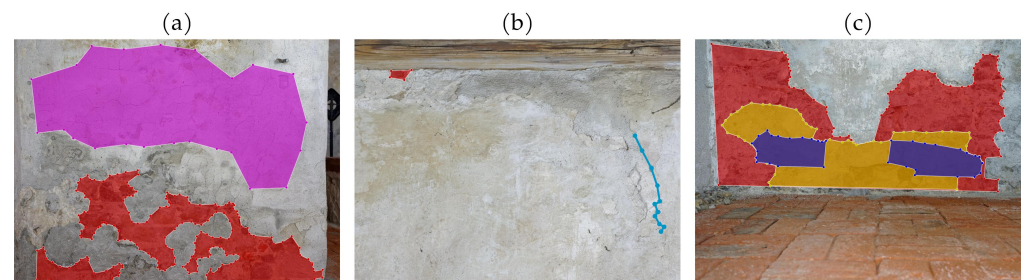
Figure 4. Examples of annotated damages: (a) areas of missing plaster (red) and craquele (purple), (b) a crack polyline (light blue) and a small missing plaster detail as a polygon (red), and (c) the synthetic multitemporal labels for the case study in t_1 (blue), t_2 (yellow), and t_3 (red) for a missing plaster area.

In total, 65 damages in three different states, assigned to four categories, were annotated as a polyline along the crack centreline or as a polygon around the affected area for craqueles, discolourations, and missing plaster.

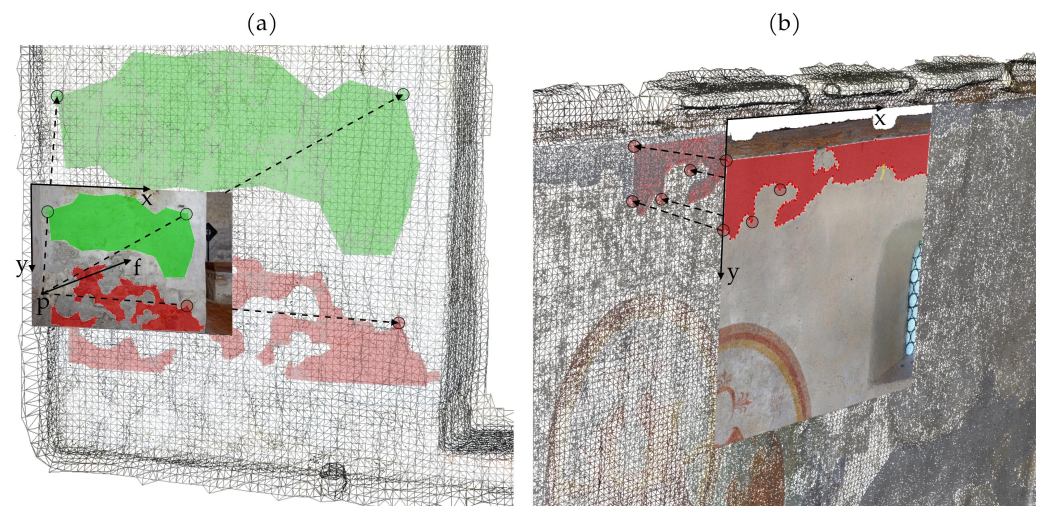
Figure 5. Exemplary mappings of 2D annotations of missing plaster (red) and craqueles (green) from the case study dataset on the triangle mesh surface; (a) an image-based central projection showing the estimated position of the camera p , the focal length f as a vector to the image centre, and the orientation of the local coordinate system and (b) an orthogonal projection from an orthophoto patch, which was registered to the 3D scene.

The ray casting itself uses the extrinsic and intrinsic camera parameters from the photogrammetric reconstruction for the mapping from 2D image information to global 3D coordinates. At this point, it is important to distinguish between the original camera images and computed orthophotos. For the original images, a pinhole camera model was assumed. Additionally, two coefficients for radial lens distortion, k_1 and k_2 (part of the bundle file [29]), as well as the focal length f were considered. The farther a pixel is from the centre of an image in the acquired dataset, the higher the influence of this distortion on the ray casting is. Figure 5 shows an exemplary mapping of an image-based annotation in the case study.

In contrast to the aforementioned image-based central projection, an orthogonal projection from the image plane was conducted for the mapping of annotations from orthophotos. Effects such as distortions are already compensated by the photogrammetric reconstruction and do not need to be considered. The global coordinate of the image origin and the global direction vectors for ordinate and abscissa vectors of the image coordinate system are the necessary information. This allows registering the orthophoto on the 3D scene and mapping the annotations to the building element surfaces.

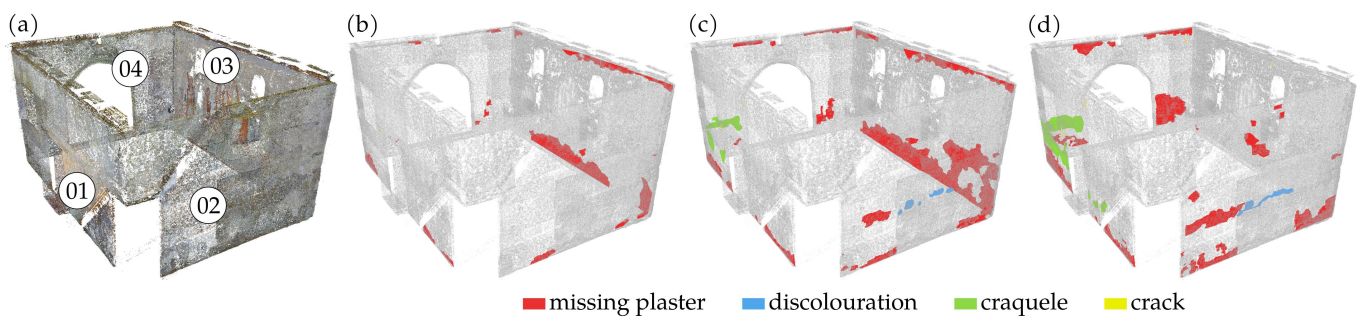
Figure 6. Three-dimensional view of (a) the segmented walls with assigned numbering 01–04 and (b,c) the mapped 3D annotations as coloured decay mapping in the states (b) t_1 , (c) t_2 , and (d) t_3 .

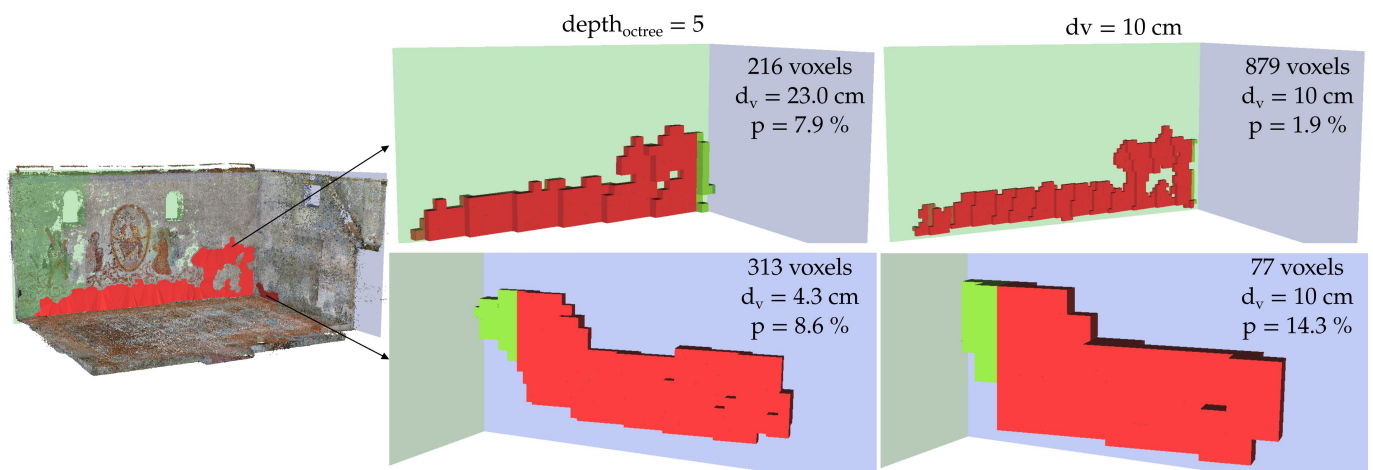
Figure 7. Three-dimensional views with wall elements and two exemplary 3D annotations from the case study dataset showing the voxel percentage to non-corresponding building elements: (green) assigned voxels and (red) not assigned voxels for octree based or defined voxel sizes with $d_{min} = 10$ cm.

With a fixed global value for d_v , a small damage object could be represented by only a single voxel under specific circumstances. Thus, it is impossible to derive a weighted distance from a voxelisation with this parameter. Considering dynamic d_v , this effect does not appear, but also influences the $p(a(t_i), b)$. By the coloured areas in Figure 7, which indicate the voxel evaluation, it is evident that geometries in room corners would be assigned to both adjacent walls using a pure distance-based assignment.

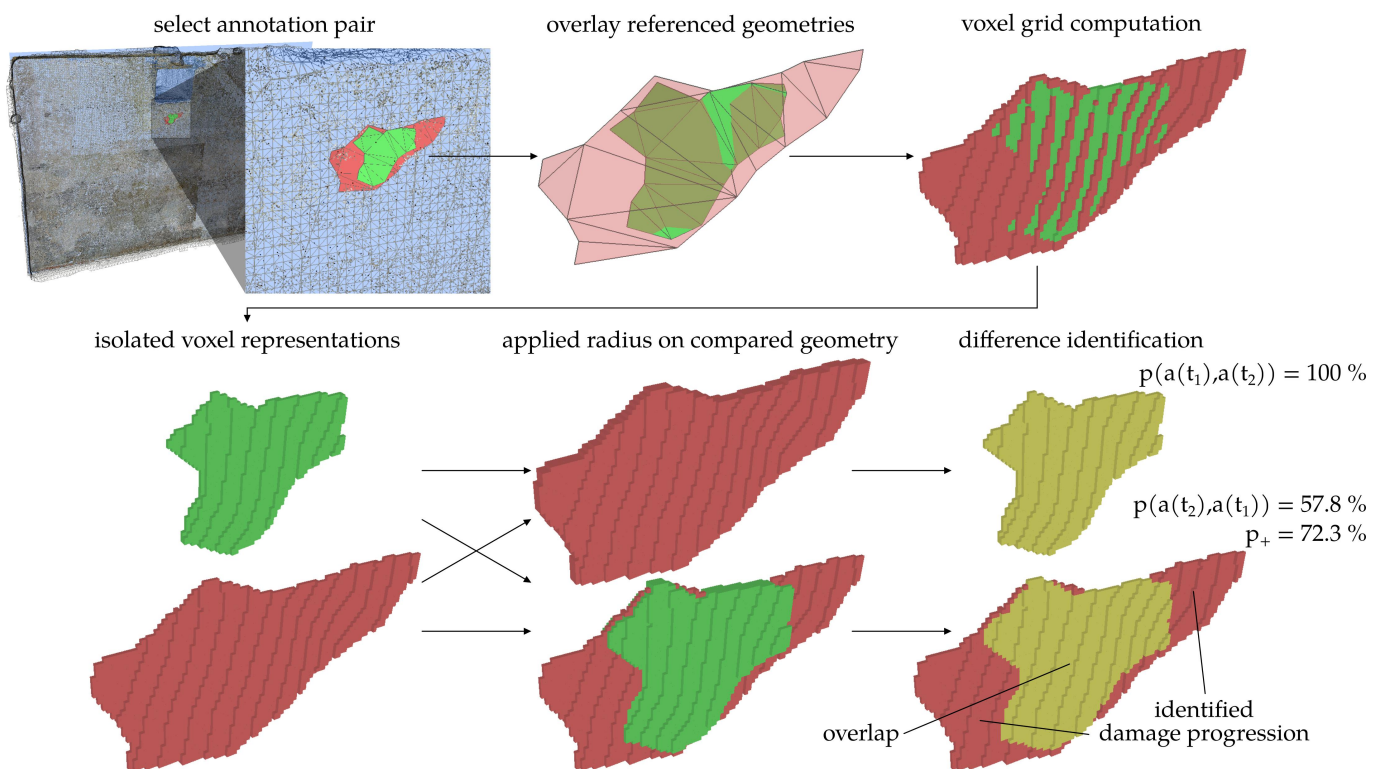
Figure 8. Voxel-based assignment and comparison of the exemplary damage from t_1 (green) and t_2 (red) in the dataset of Wall 02 using the parameters $d_v = 0.5$ cm and $r_v = 1$, resulting in an identified overlap (yellow) and a damage growth of 72.3%.

The algorithm for assigning multitemporal 3D damage annotations $a(t_i)$ and $a(t_{i+1})$ of the states t_i and t_{i+1} is based on the voxelisation of the geometries [33]. To accelerate the detection of the overlapping AABBs, the geometries are checked first. Subsequently, a common voxel grid with a defined d_v is applied on both geometries and the occupancy of the individual voxels is evaluated. This results in the percentage overlaps $p(a(t_i), a(t_{i+1}))$ and $p(a(t_{i+1}), a(t_i))$ for the percentage of intersection of damage geometry $a(t_i)$ and $a(t_{i+1})$, respectively. If one of the values is above a defined p_{min} , the assignment is valid. To compensate the mentioned offset among datasets of different states, an integer voxel radius (r_v) is additionally applied, which co-occupies a defined number of neighbouring voxels of a geometry. Figure 8 illustrates the steps of the algorithm with the exemplary damage from the case study dataset.

The result of the voxel-based comparison for an assigned set of damages is shown in Figure 8 along with the identification of the localised damage progression. The growth of the same damage among two compared states is expressed as the percentage of detected difference voxels. Thereby, p_+ stands for a growth since the previous inspection, since p_- for a shrinkage and p_0 for the overlap of the compared damage geometries. Here, due to a better discretisation of the geometry, the accuracy of the percentage value increases with smaller d_v , but the computational effort increases at the same time. The percentages of growth p_+ and shrinkage p_- enable an automated categorisation or evaluation of the damages. This could also lead to a rating of the damages based on the type of damage, the identified affected building elements, the location on the building element, and the computed damage progression.

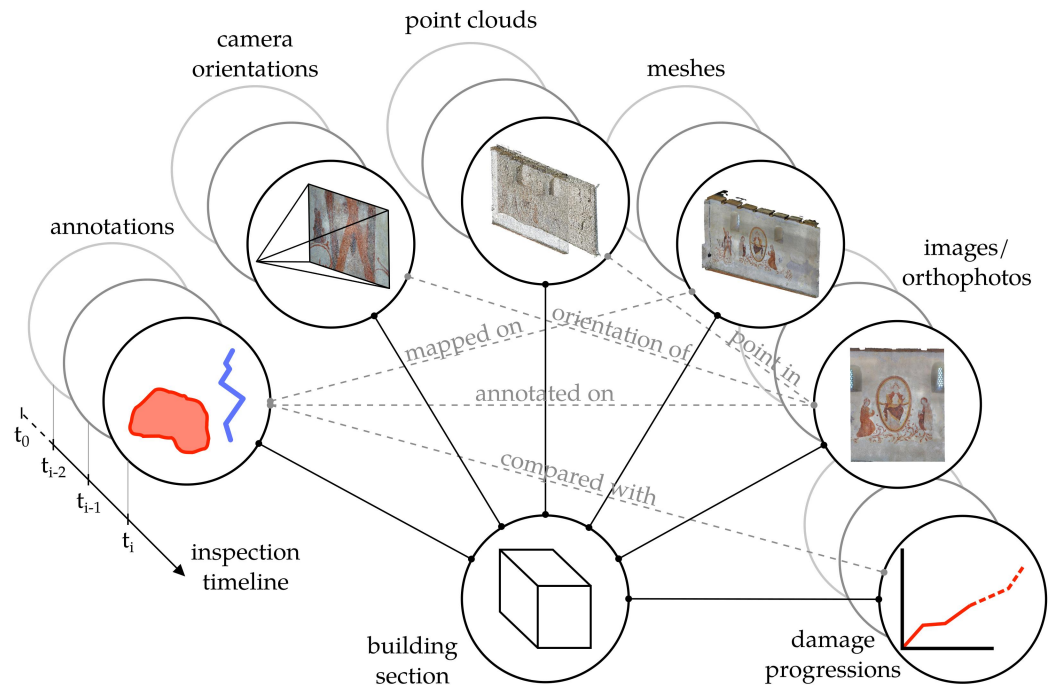
Figure 9. Schema of the linking between the different data entities in the case study to achieve a comprehensive condition history on the inspection timeline.

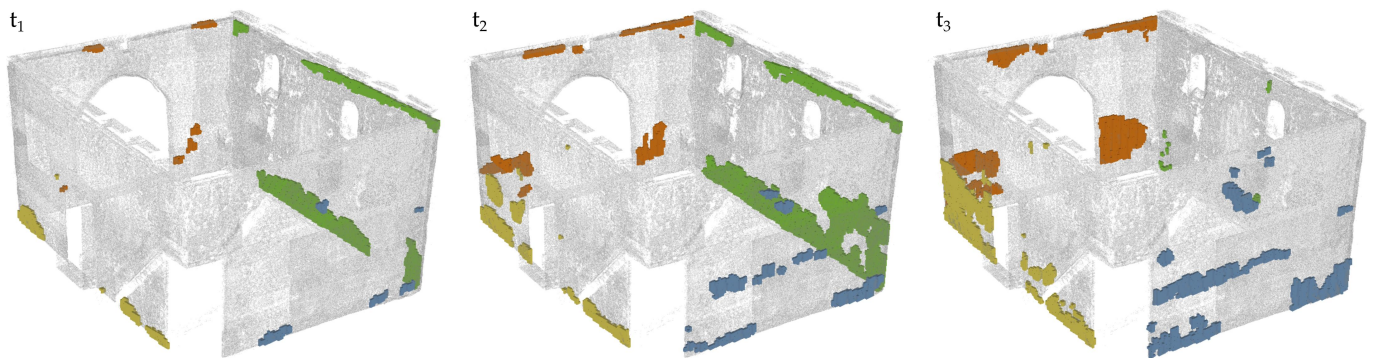
Figure 10. Voxelised ($d_v = 5$ cm) and assigned damages of each annotated state for the wall elements ($d_{min} = 20$ cm, $p_{min} = 25\%$) in the case study dataset: Wall 01 (yellow), Wall 02 (blue), Wall 03 (green), and Wall 04 (orange).

The dimensions of the 3D annotations are distributed quite heterogeneously depending on the type of damage, which complicates the definition of a common voxel size d_v . For the analysis of the dataset, a voxel size of 5 cm was defined in order to obtain a limited number of voxels for relatively large geometries. Alternatively, an adaptive voxel size could be chosen, which is based on the size of the individual damage geometries, e.g., by specifying an octree depth before voxelisation or by considering a percentage of the largest dimension. This would also prevent from one-voxel discretisation of relatively small geometries, which does not lead to the desired weighted distance and, thus, produce instable assignment results. However, d_v should then be considered when analysing the results. The distance threshold $d_{min} = 20$ cm was defined dependent on the distance of the components to the reconstructed point cloud, which served as the target for ray casting. The number of assigned damages at each inspection applying the discussed parameters is

provided for the walls in Table 1. The corresponding voxel evaluation results are presented in Figure 10.

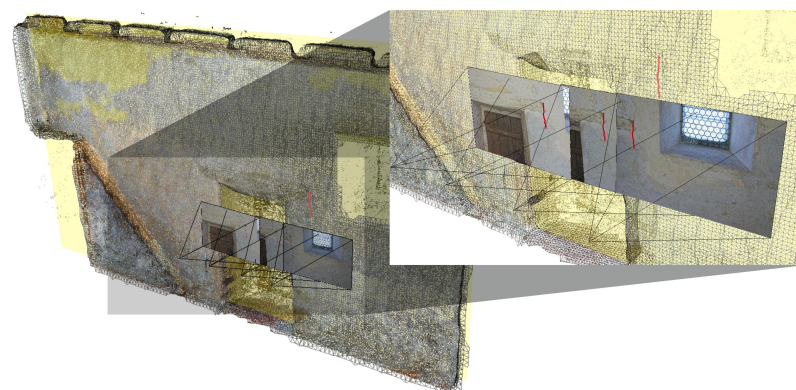
Figure 11. Back-projection of a crack annotation on Wall 01 to images containing the damage.

After assigning the damage annotations to the corresponding building elements, the assignment of the corresponding images was conducted. This was carried out by back-projecting the damage geometries into the respective cameras and image planes. As an initial filter, the general visibility of the geometries in the image was verified, in order to exclude images that do not contain the required region. The selected images were then filtered by distance to the damage, angle to the centre plane of the damage geometry, or the distance of the 2D annotation to the centre of the image. Figure 11 shows the stepwise filtering process for the described criteria. This process was repeated for each annotation to create the assignments among images and damages.

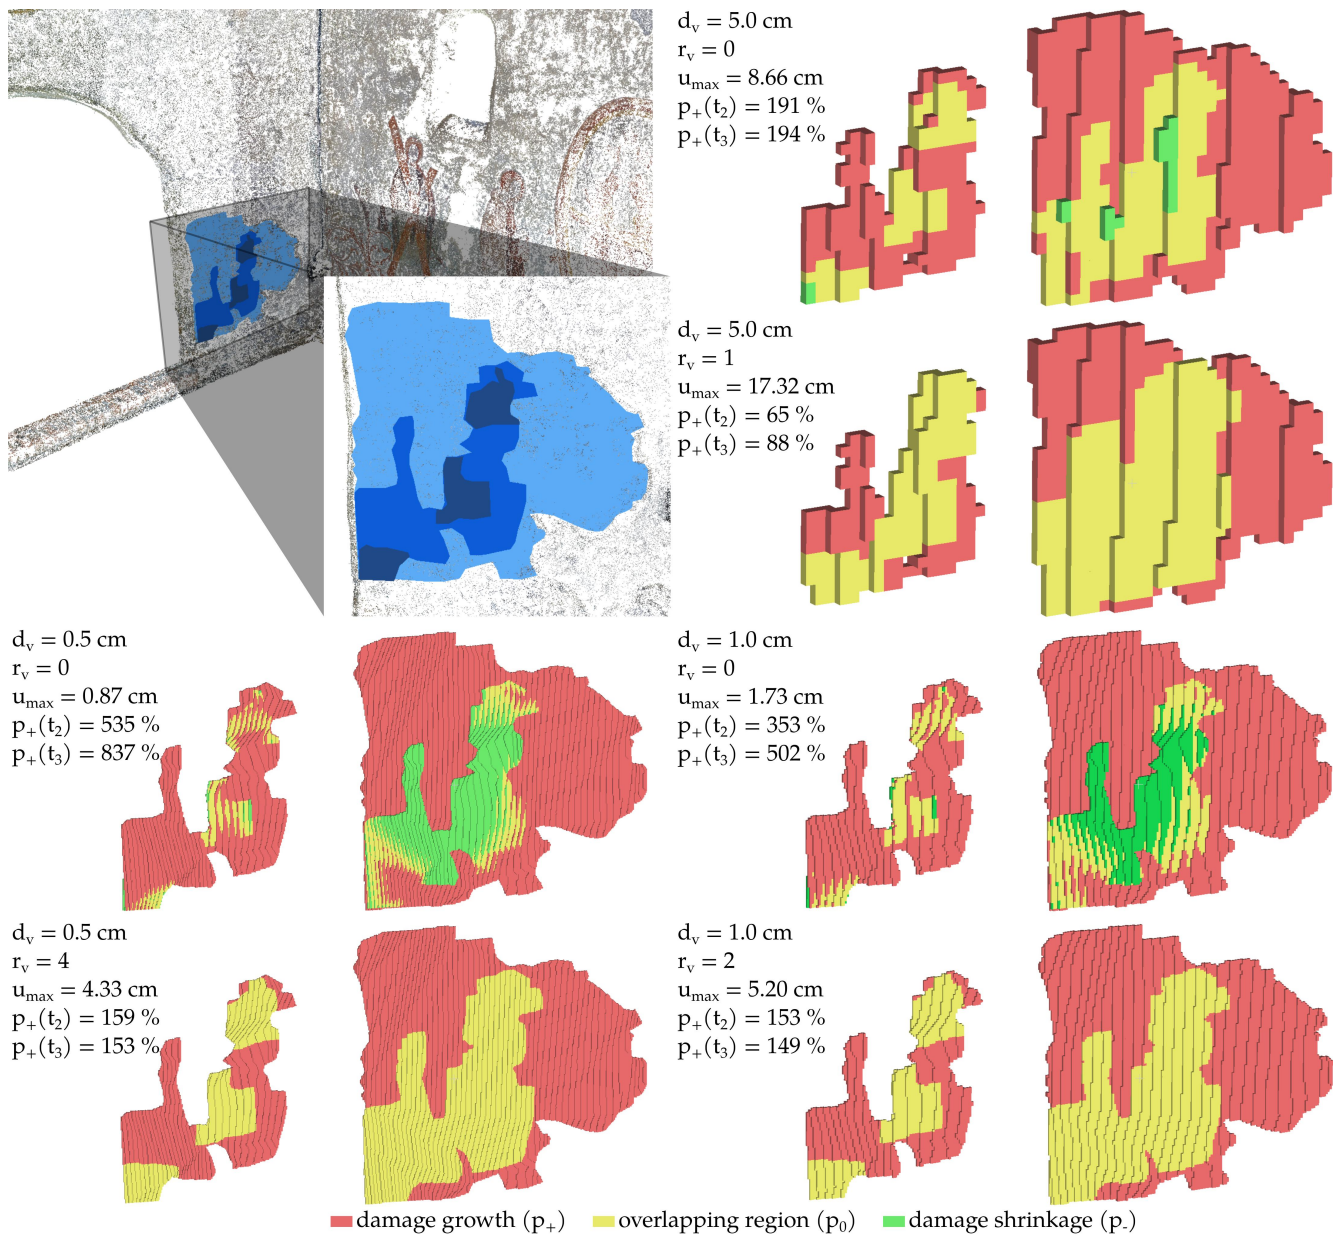
Figure 12. Results for a missing plaster annotation applying the voxel-based assignment and comparison of (left of each pair) t_1 and t_2 and (right of each pair) t_2 and t_3 showing the effects of a too small definition of r_v and the percentage growth p_+ computed from different d_v .

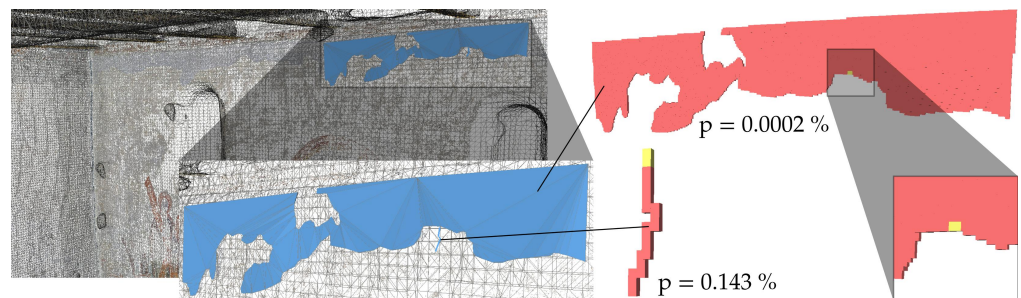
Figure 13. Percentage of overlapping voxels (yellow, $d_v = 0.5 \text{ cm}$, $r_v = 1$) for two near damage annotations (blue) that are not assigned, whereas a bounding box or distance check would result in a valid assignment.

Compared to simpler assignment methods such as AABBs or a distance threshold, the advantageous effect of the voxelisation method is in avoiding erroneous assignments of near or partly overlapping damage geometries (see Figure 13). There, the evaluation of the percentage of commonly occupied voxels does not lead to an assignment. Additionally, the procedure after the voxelisation is independent of the geometry class of the damage. For example, missing plaster could be documented as a triangulated surface in one inspection and as a dense point cloud in another inspection. The proposed algorithm could handle both types of data without modifications.

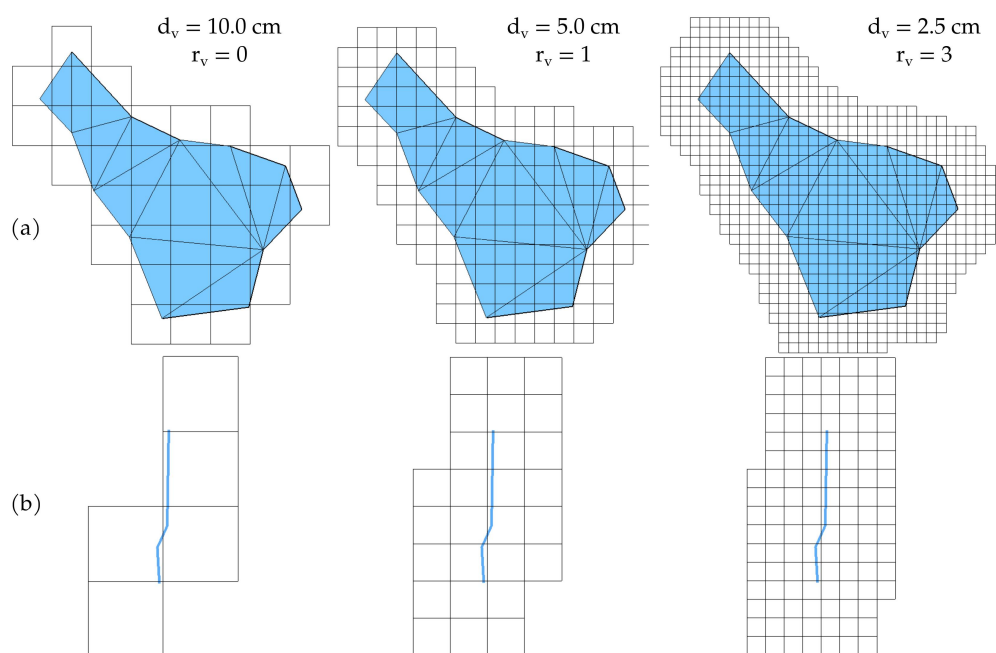
Figure 14. Different combinations of d_v and r_v (all lead to $u_{max} = 17.3$ cm) for annotated (a) missing plaster surface and (b) crack polyline.

For this purpose, a voxel grid was generated around the assigned damages and evaluated according to the respective timestamps of the surveys. The accuracy of the results depends directly on the accuracy of the registration of the point clouds (or meshes). Since a radius r_v must be determined to compensate for the offset, as described in Section 2.4.4, it influences also u_{max} . The voxel radius r_v also helps to shift the discrete geometry more towards a centred position inside the generated voxel representation [33]. This effect does not occur with a rough voxelisation without an applied radius, as shown in Figure 14.

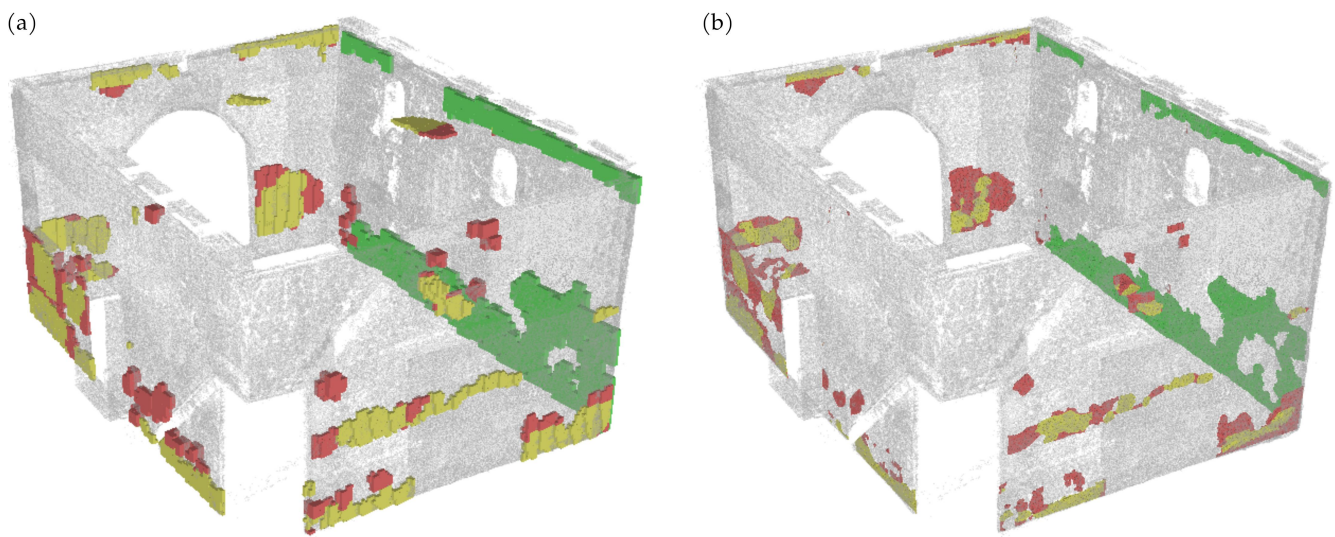
Figure 15. Three-dimensional view of the voxelised and compared full annotation dataset (comparison of t_2 and t_3) in two variants with (a) a rough computation using $d_v = 5$ cm and $r_v = 1$ and (b) a more detailed computation using $d_v = 0.5$ cm and $r_v = 4$ (red: new damaged regions, yellow: regions already identified in t_2 , and green: repaired or not re-identified regions).

Furthermore, with a smaller voxel size d_v , the accuracy of the percentage difference approximation is increased. Figure 15b shows the visual comparison of the dataset of the case study with applied parameters $d_v = 0.5$ cm and $r_v = 4$ for all damages. The results of the percentage difference for Wall 02 additionally are listed in Table 2. From the determination of the discrete changes of the damage geometries, the damage increment also allows for a localisation and evaluation depending on its position.
